Living with the West Florida shore

Larry J. Doyle, Dinesh C. Sharma, Albert C. Hine,
Orrin H. Pilkey, Jr., William J. Neal, Orrin H. Pilkey, Sr.,
David Martin, and Daniel F. Belknap

Duke University Press Durham, North Carolina 1984
Property of CSC Library

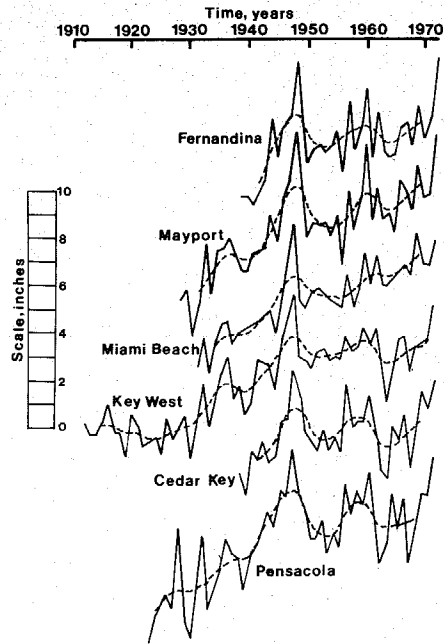
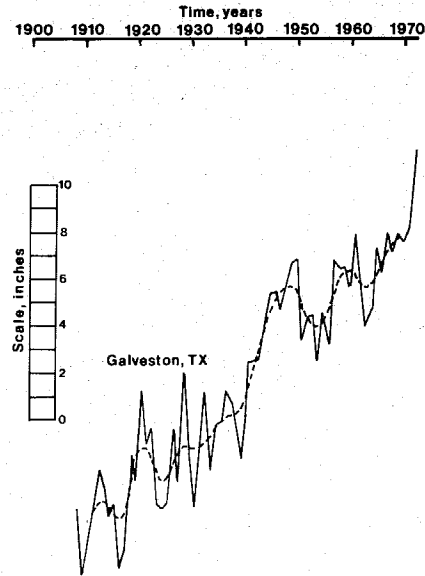
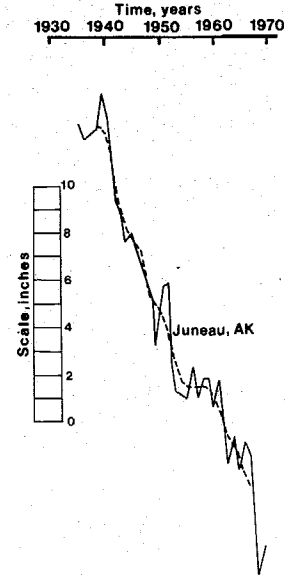
The sea-level rise in Florida:
approx. 7.2 inches/50 years.

Example of sea-level rise due to
sinking of land.

Example of sea-level drop
due to rising land.

Fig. 1.2. Sea-level changes on various shorelines. The sea-level rise in Florida is shown to the left and is typical of most of the American shoreline. The sea level in Galveston, Texas, is rising rapidly because the land is sinking due to groundwater extraction. Off Juneau, Alaska, the sea level seems to be dropping because the land is rising.

Notice how irregular and “jagged” the tide-gauge, sea-level curves are as shown in figure 1.2. There appear to be cycles of about 5 years involving ups and downs ranging from 1 inch to 5 inches. The effect on the beaches of these short-term sea-level fluctuations is not known. However, when we smooth out the jagged peaks on these graphs, we can see that there has been a general rise in sea level since the time the tide gauges were installed. Certainly, the rise over the past 40 to 80 years has been enough to cause a lot of beach retreat, and more should be expected.

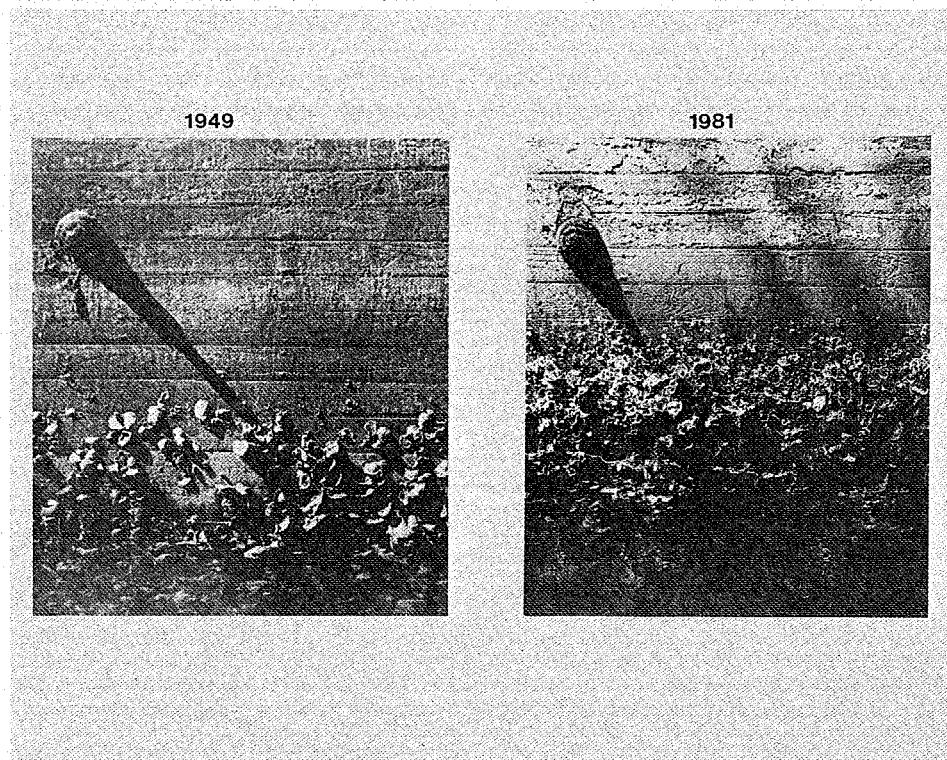
Fig. 1.3. Barnacles and oysters have migrated upward on these pilings at Miami, demonstrating a sea-level rise from 1949 to 1981. Photo courtesy of Hal Wanless.

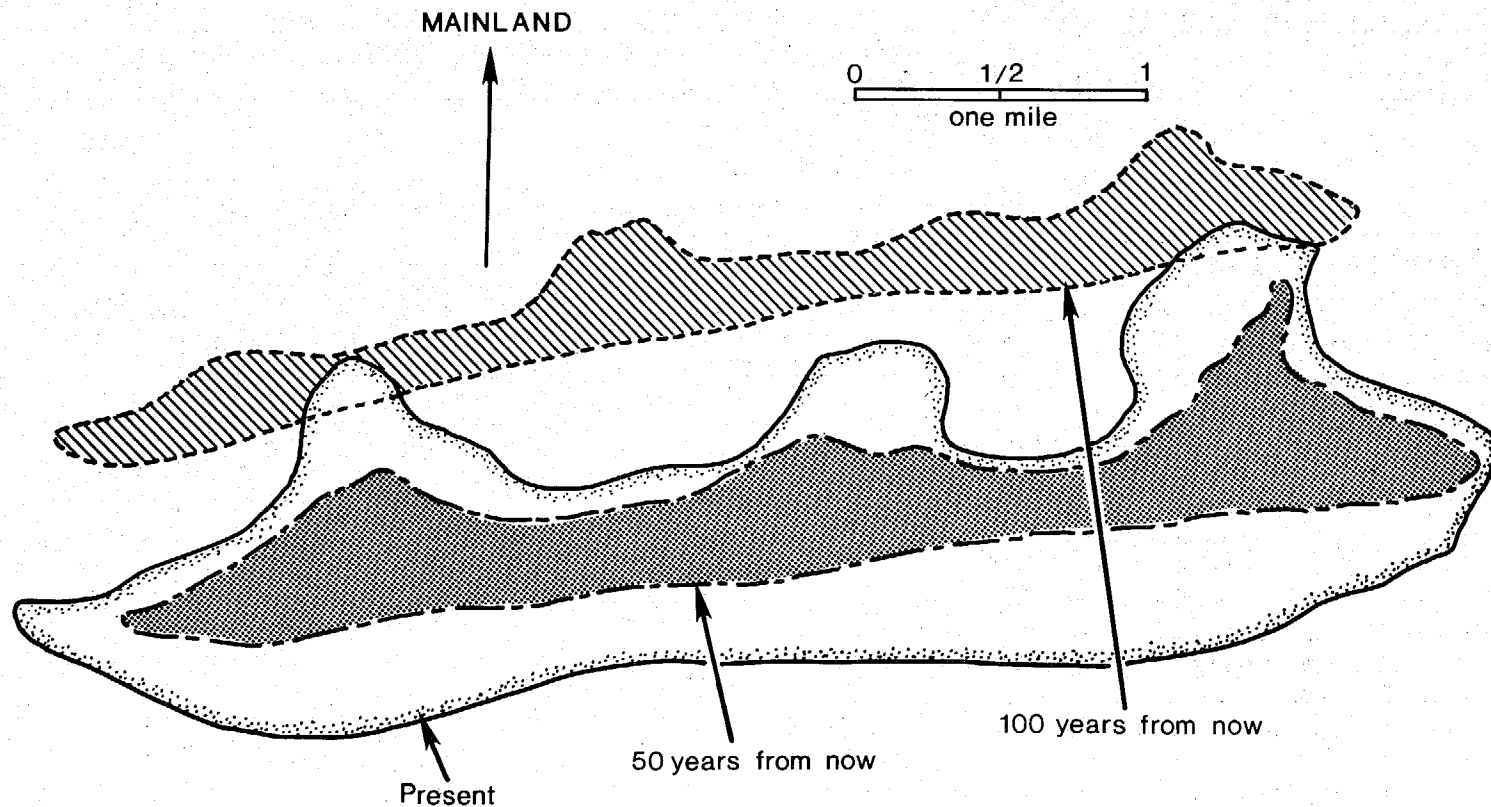
Fig. 1.4. Theoretically, a very small rise in sea level should produce a very large horizontal shoreline retreat.

If you use a shell book to identify specimens from a beach, you will find that lagoon shells also can be found on the ocean-side beach. As some islands migrate landward (figs. 1.4 and 1.5), they reexpose the shells that once lived in back-island environments and were buried there. In a few hundred or a thousand years the lagoon shells are thrust up onto the ocean-side beach. But as any beach buff knows, not all beach seashells are fossils by any means. The coquina clam lives in the upper beach and hastens to rebury itself when exposed by sandcastle builders.

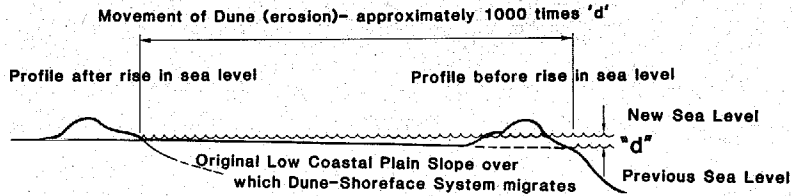
Fig. 1.5. A hypothetical example of barrier island migration assuming a 1-foot rise in sea level pushing across the West Florida coastal plain.

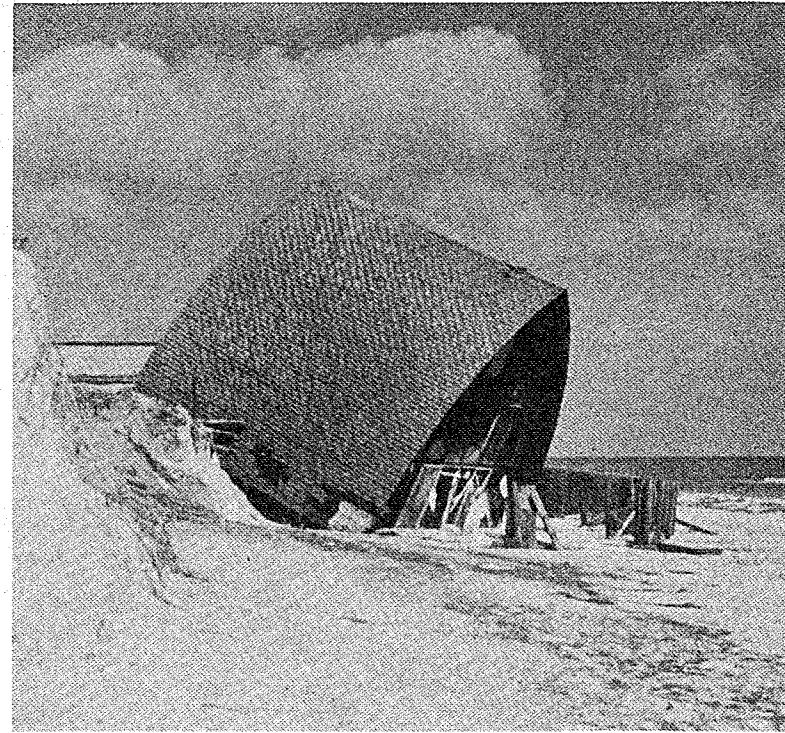
Fig. 1.6. A "slab-on-grade" house after Hurricane Eloise (1975) on Panama City Beach. This building was not on pilings and was undermined. Note that the small seawall was ineffective in saving the house.

If the sea level simply rose and no other forces came into play at the shoreline, land areas would gradually flood at a rate that would be totally predictable. As everyone knows, however, the surface of the sea has waves on it, and these waves can become very large during storms. Waves, especially storm waves, can move huge amounts of beach sand in a matter of hours. The higher the sea level, the farther inland storms are likely to reach. In this way the sea-level rise and breaking storm waves combine to cause problems for the Florida shoreline dweller (figs. 1.6, 1.7, 1.8, and 1.9).

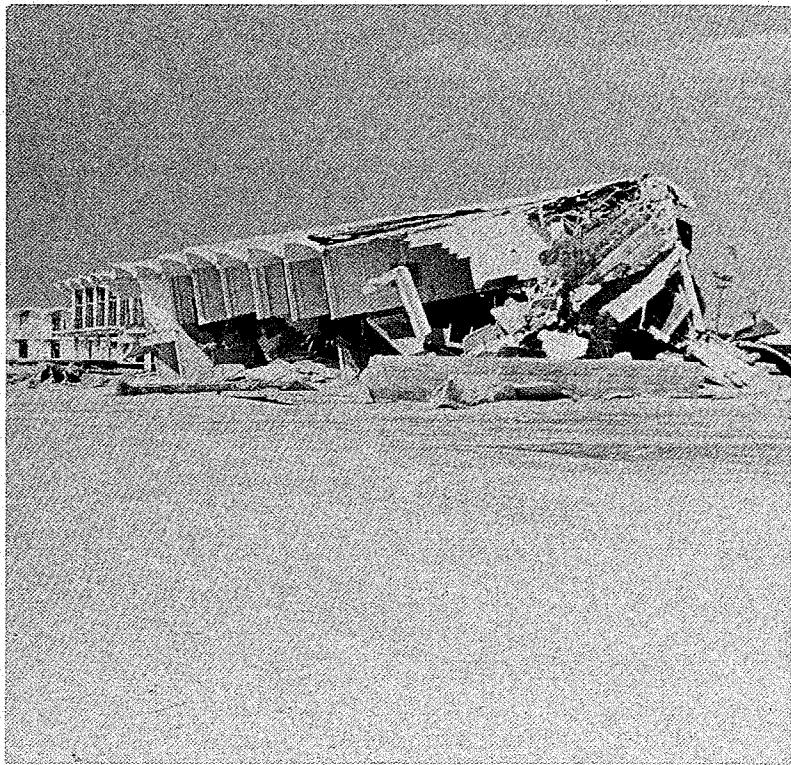
Fig. 1.7. Beach-front motel after Hurricane Eloise (1975) struck Panama City Beach.

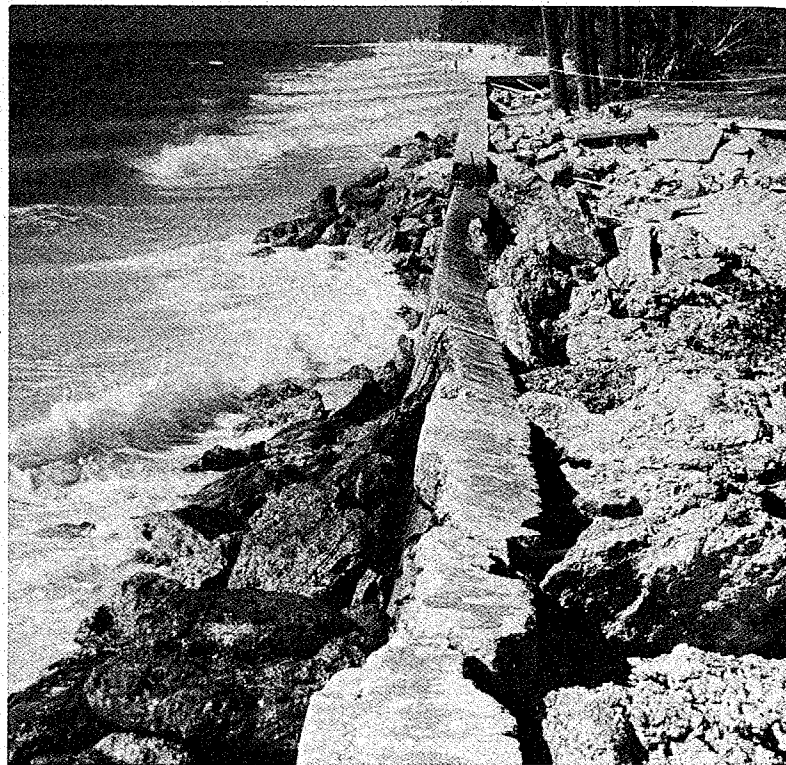
Fig. 1.8. A failed seawall and a destroyed beach on Longboat Key. Photo by Judson Harvey.

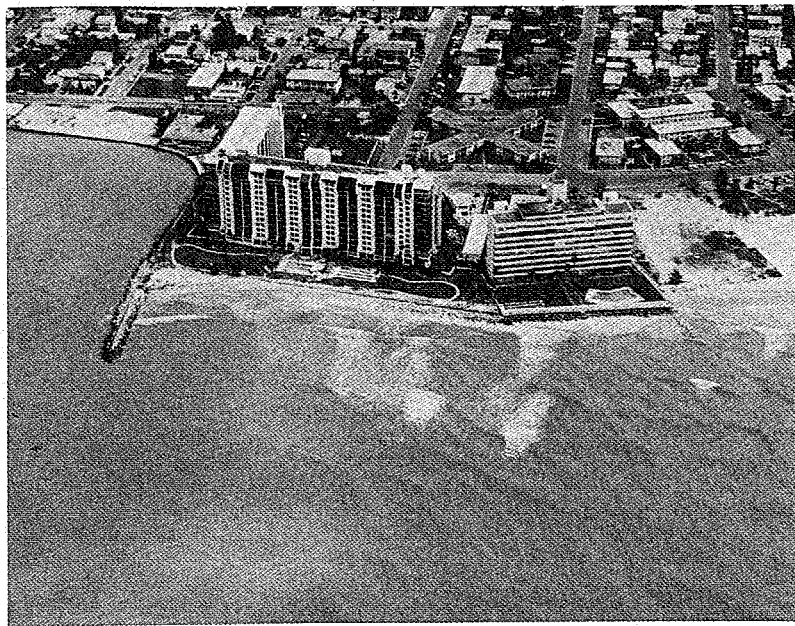
Fig. 1.9. Protruding condos on an eroding Pinellas County beach. Photo by Al Hine.

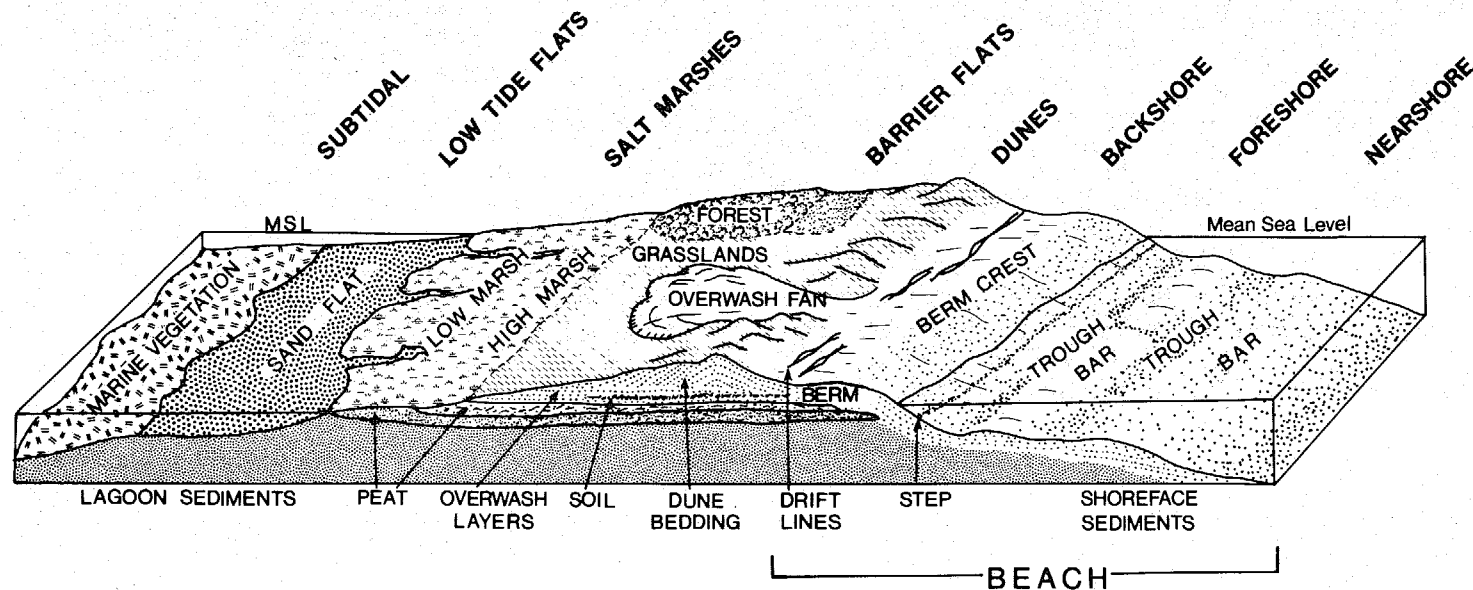
Fig. 2.1. Beach and barrier island natural environment.

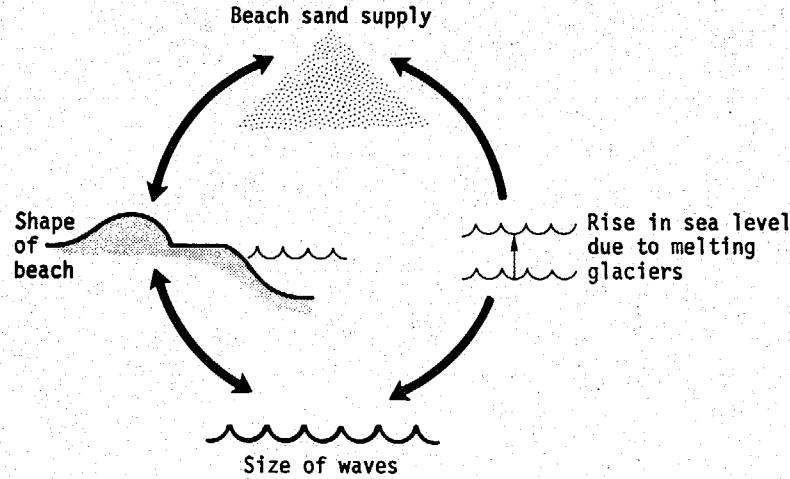
Fig. 2.2. The dynamic equilibrium of a beach.

librium diagram of figure 2.2. The factors that control beaches are (1) the size of the waves, (2) the rate of sea-level rise, (3) the amount and type of sand, and (4) the shape of the beach. These factors are said to be in a dynamic equilibrium because when one factor changes, the others adjust accordingly to maintain a bal-

ance. For example, during a storm when the waves get larger, the beach responds by changing its shape. If fresh sand is pumped onto a beach (beach replenishment), the slope or shape of the beach will vary according to the grain size of the new sand: the finer the sand, the gentler the beach slope.

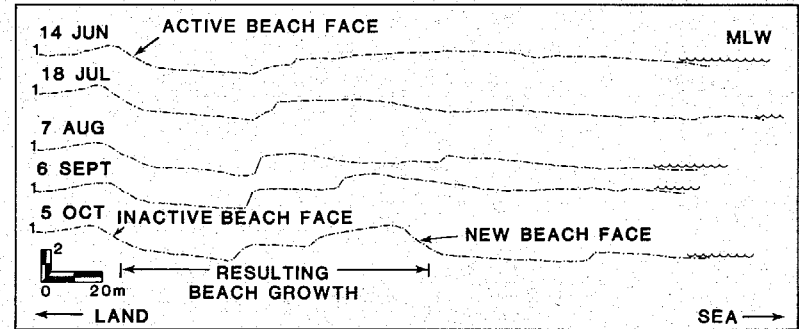
Fig. 2.3. Beach profiles.

after a storm (fig. 2.3). The flat beach can be explained in terms of dynamic equilibrium: as wave energy increases, the storm waves attack the beach and dunes and erode them, moving sand from the upper beach to offshore, thus changing its shape (fig. 2.9). If a hot dog stand or beach cottage or condominium happens to be located on the upper beach or on the first dune, it may disappear along with the sands being transferred to the lower beach. Much of this newly eroded sand is stored in offshore bars. These bars can build up during a storm and can partially protect the beach by causing waves to break on them.

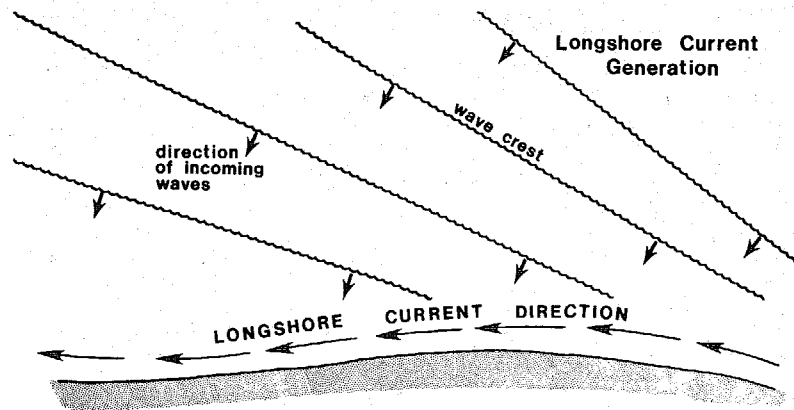
Fig. 2.4. Longshore currents are formed by waves striking the beach at an angle.

Sometimes when we go swimming at the beach we end up a long way down the beach from where we started. We have been carried there by the longshore current, which obviously is responsible for longshore transport. Such currents result from waves approaching the shore at an angle (fig. 2.4), which causes a portion of the breaking waves' energy to be directed along the beach. The strength of the longshore current rapidly drops off seaward from the breaking waves. Some days when there are at least 3-foot breaking waves, and you can feel the longshore current running along the beach (some people call this undertow), swim beyond the point where the waves are breaking. You will find that you are not carried down the beach nearly so fast as before.

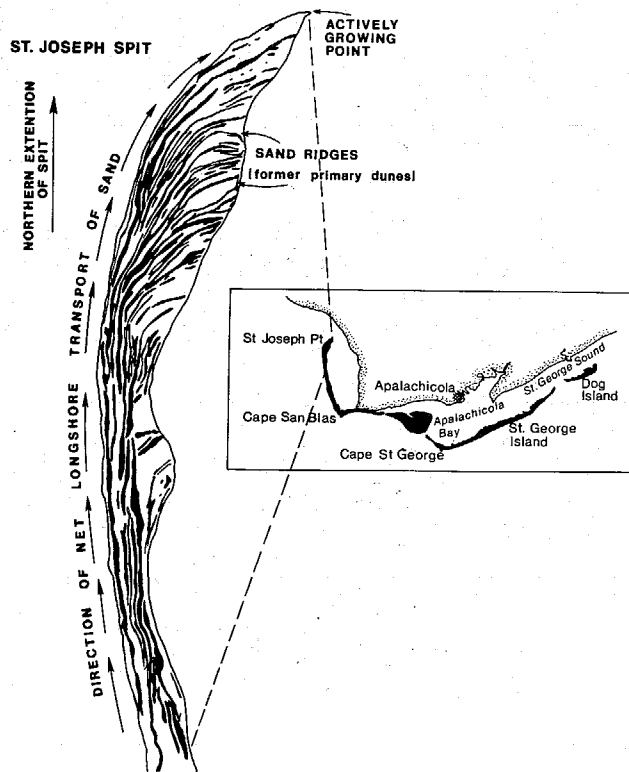
Fig. 2.5. St. Joseph Spit has been formed by buildup of dune ridges paralleling the beach. The sand that forms the ridges is carried to the north by longshore currents in the surf zone.

Sand transported along the shore may ultimately reach the end of the beach or barrier island. The island may grow laterally like St. Joseph Spit in Wakulla County (fig. 2.5). This is called a recurved spit. More commonly, the sand is deposited into a tidal inlet that separates 2 barrier islands. Good examples of inlets filling in rapidly with sand from longshore transport are the old channels across Captiva Island in Lee County (fig. 2.6) and Stump Pass in Charlotte County (fig. 2.7). Often sand may be transported right

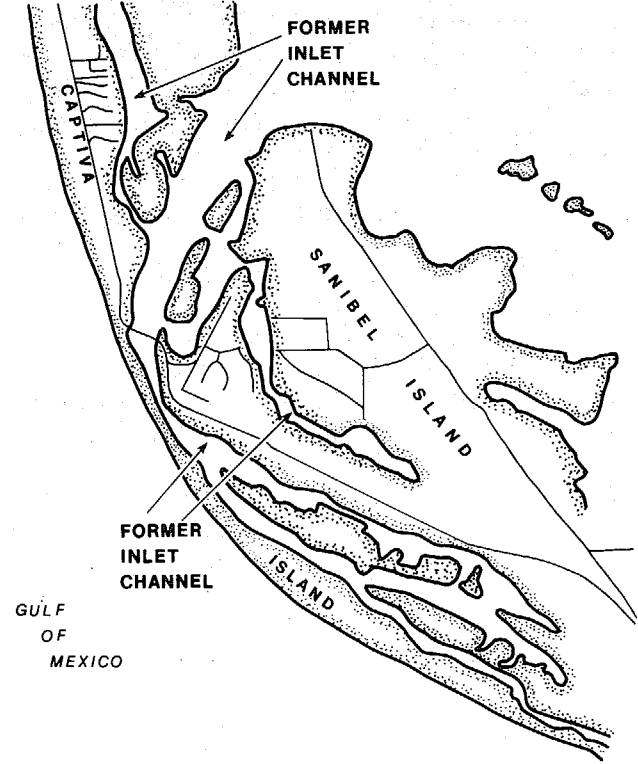
Fig. 2.6. Map showing the position of channels marking former inlets that have since closed up.

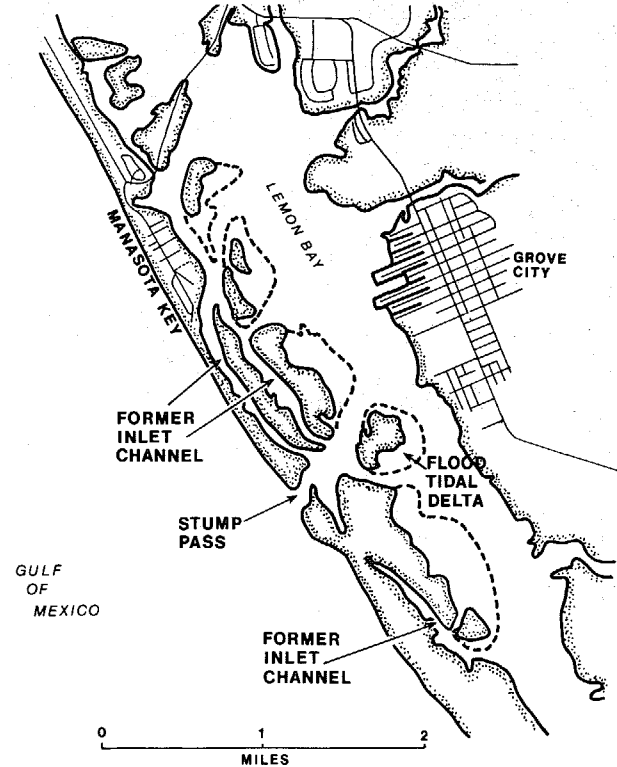
Fig. 2.7. Inlet filling at Stump Pass, Charlotte County.

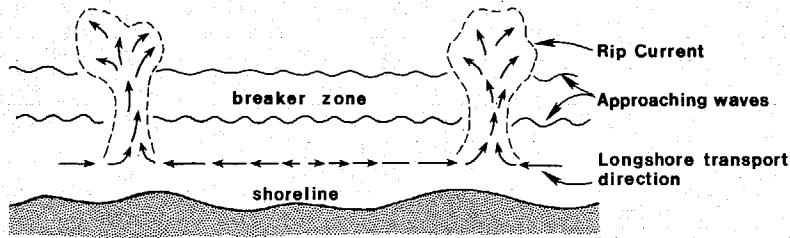
Fig. 2.8. Rip currents that are dangerous to swimmers form when 2 long-shore currents meet head-on.

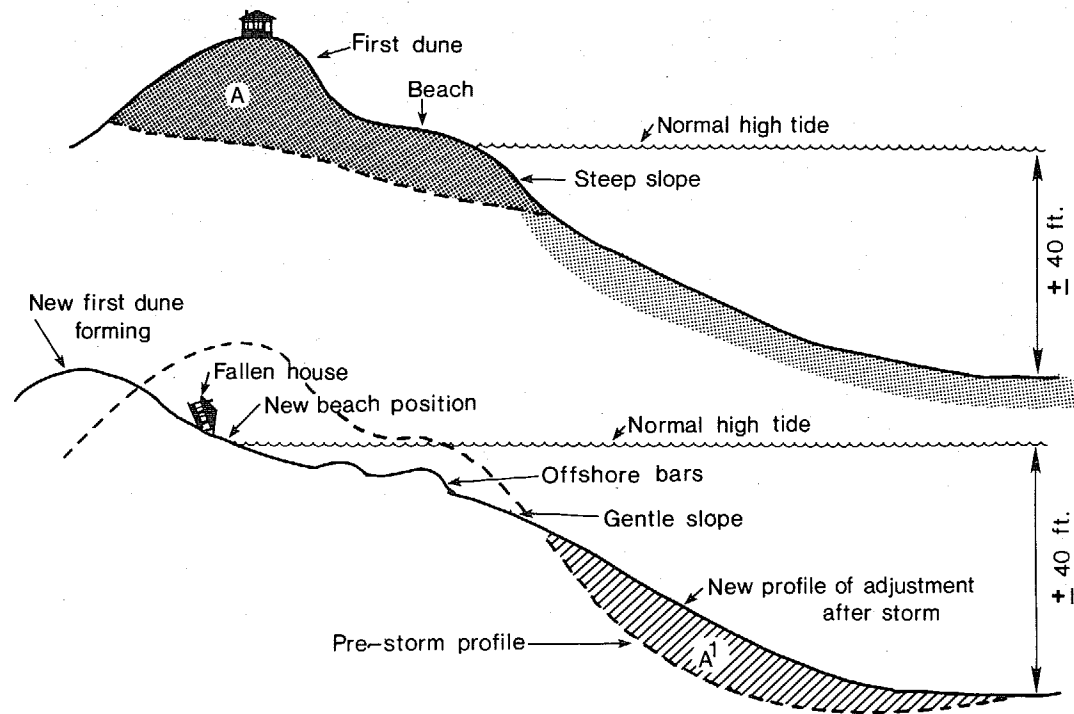
(Shaded area A¹ is approximately equal to shaded area A.)

Fig. 2.9. How beaches respond to a storm. The net result is beach flattening, which allows storm waves to dissipate their immense energy over a broad surface.

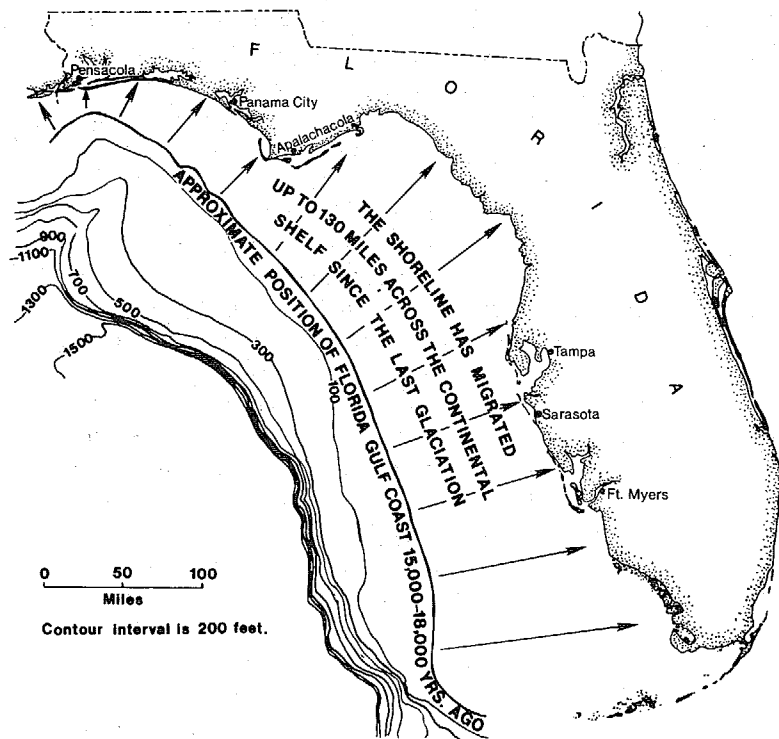
Fig. 3.1. Position of the Florida shoreline 15–18,000 years ago.

To illustrate why and how barrier islands formed, let us begin by dropping sea level by 300 feet or more. This would place Florida's Gulf Coast shoreline between 20 and 100 miles seaward of its present position (fig. 3.1), which is the situation that existed 15,000 or more years ago. Vast glaciers covered the high latitudes of the world, and so much water was tied up in these ice caps that sea level was lowered, exposing most of the present-day continental shelf. When the ice began to melt, sea level began to rise. As the valleys, which were formerly the pathways of the rivers flowing to the sea, were inundated (fig. 3.2), the rising water formed embayments. A glance at a map of today's shoreline shows many such flooded valleys, especially along the Atlantic coast. Tampa Bay and Charlotte Harbor are 2 prominent examples on the Gulf Coast (fig. 1.1).

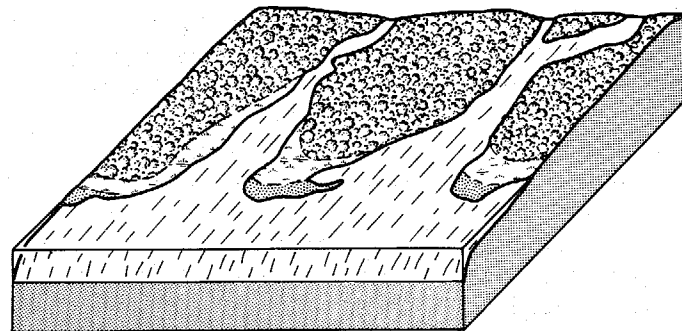
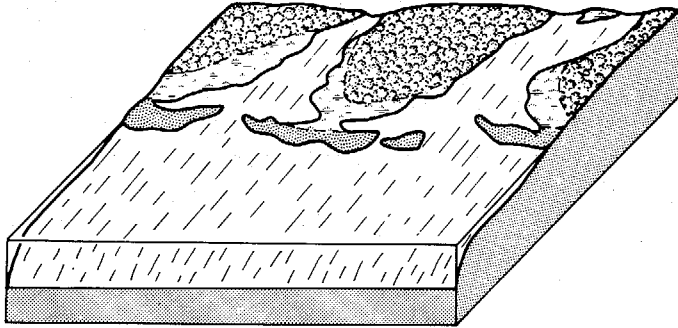
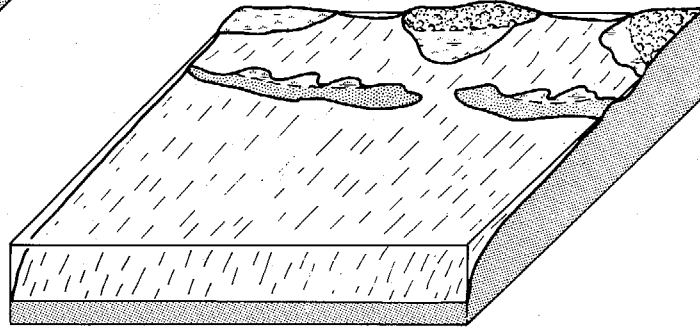
Stage 1: Flooding of river valleys

Stage 2: Formation of spits along headlands

Stage 3: Separation of barrier from mainland

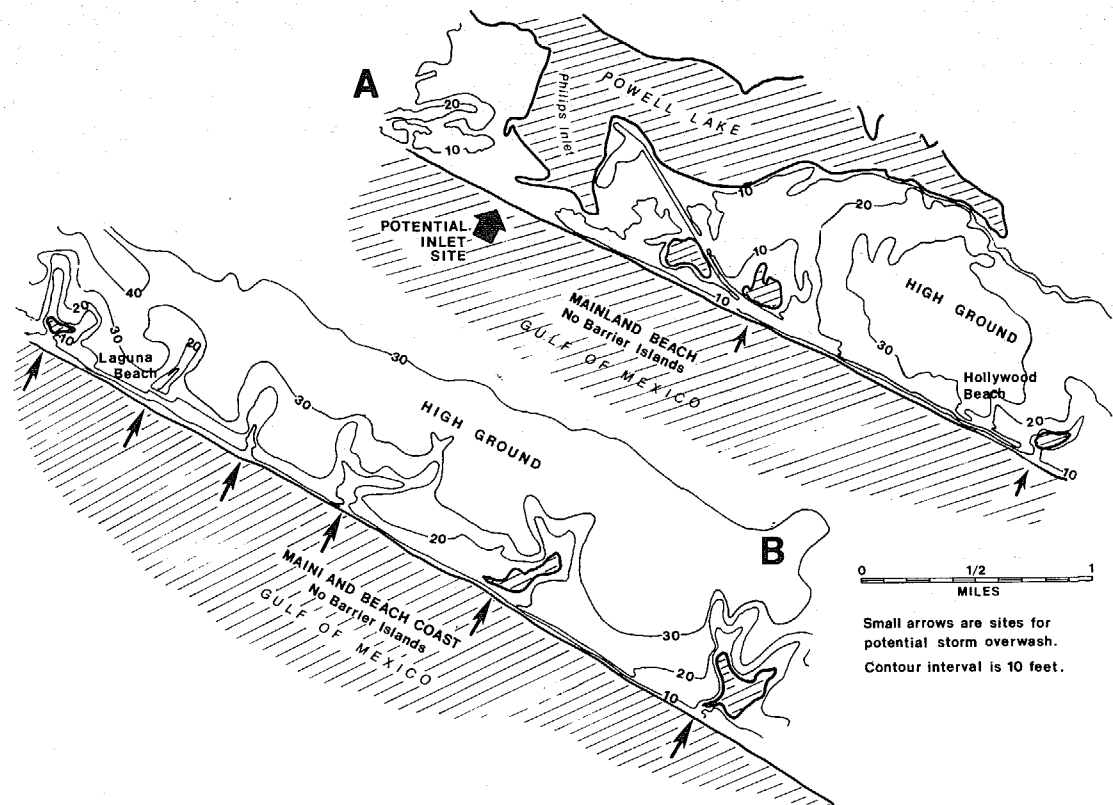
Fig. 3.3. Potential sites of washover and inlet formation for 2 stretches of the Florida shore.

called passes by Floridians) have cut through many of Florida's existing barrier islands in historical storms, and they will cut through islands in the future (figs. 3.3 and 3.4). Between 1883 and 1981 Knight, Don Pedro, and Little Gasparilla islands have had 5 inlets sliced through them. Shell Island has had several inlets in the past, all of which have closed up. Honeymoon and Caladesi islands are separated by the appropriately named Hurricane Pass.

Tidal inlets are highly dynamic and visible factors that can significantly affect and alter the adjacent barrier islands. Very large tidal inlets such as Tampa Bay or Boca Grande Pass (fig. 3.3) do not move great distances in a lateral direction. However, they build large seaward shoals called ebb-tidal deltas. The shoals can extend up to 3 miles offshore and will retreat or bend in response to incoming waves. As a result, the level of wave energy that a nearby beach receives may be focused or dispersed, and the beach will respond accordingly. So, as the offshore shoals change, so do the beaches. In this manner the inlets control the beaches.

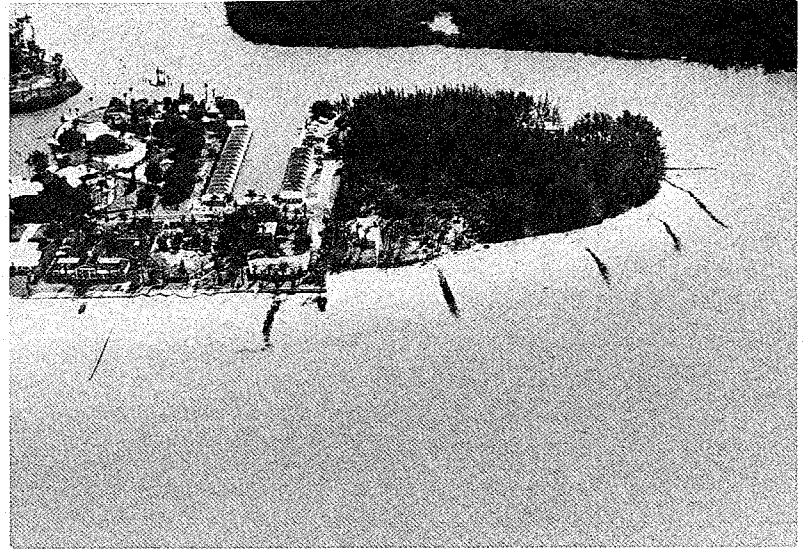
Fig. 3.4. Very rapid erosion on a beach adjacent to an inlet. The beach (in Naples, Florida) has retreated past the landward end of the groins. Photo by Al Hine.

Much smaller inlets such as Blind Pass in Pinellas County migrate laterally very rapidly in the direction of net longshore transport. This activity poses obvious hazards (fig. 3.4). If a condominium is constructed on the downdrift side of such an inlet, that structure will soon be threatened by the migrating inlet. Stabilizing efforts are extremely costly and frequently futile. Consequently, construction near all types of inlets should be avoided.

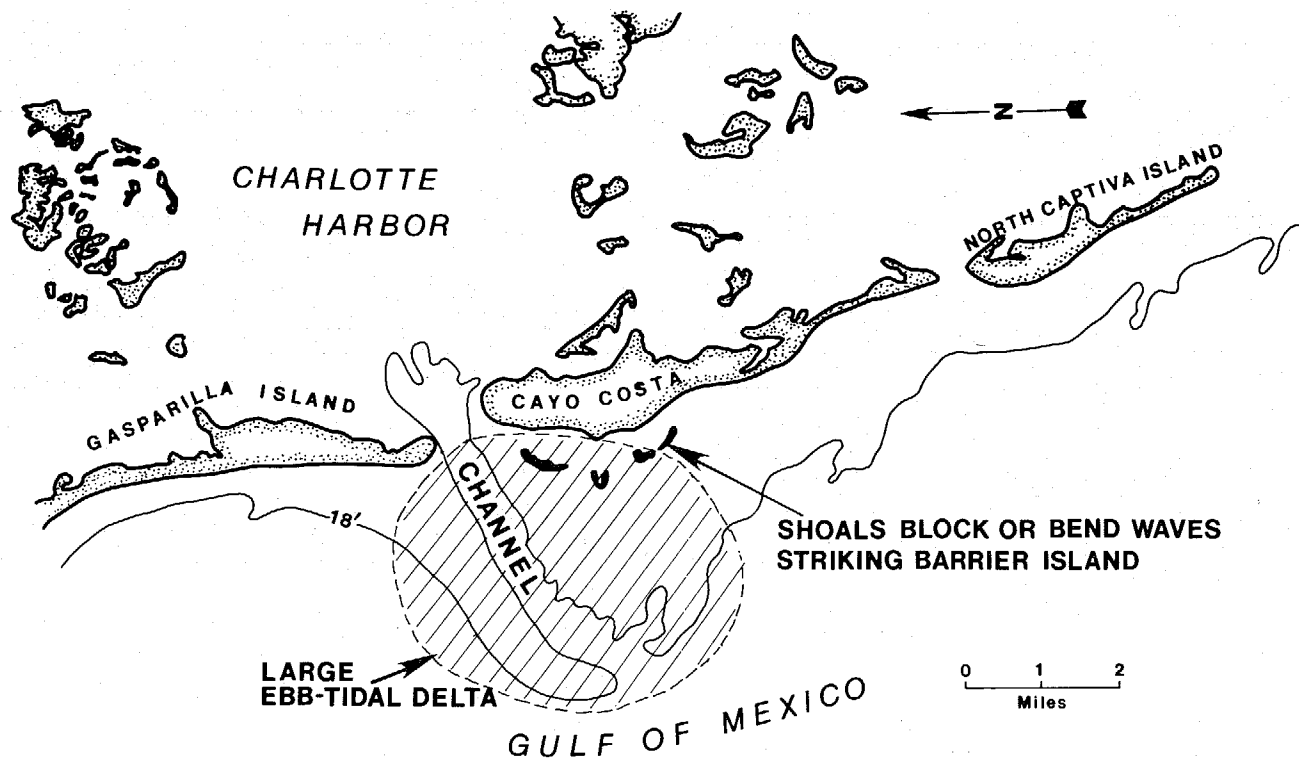
Fig. 3.5. The tidal delta between Gasparilla Island and Cayo Costa.

away. Figure 3.5 shows the general location of the tidal delta in Cayo Costa Pass. Shoals building up on the tidal delta affect the waves striking Cayo Costa, which in turn affects the shape of the island.

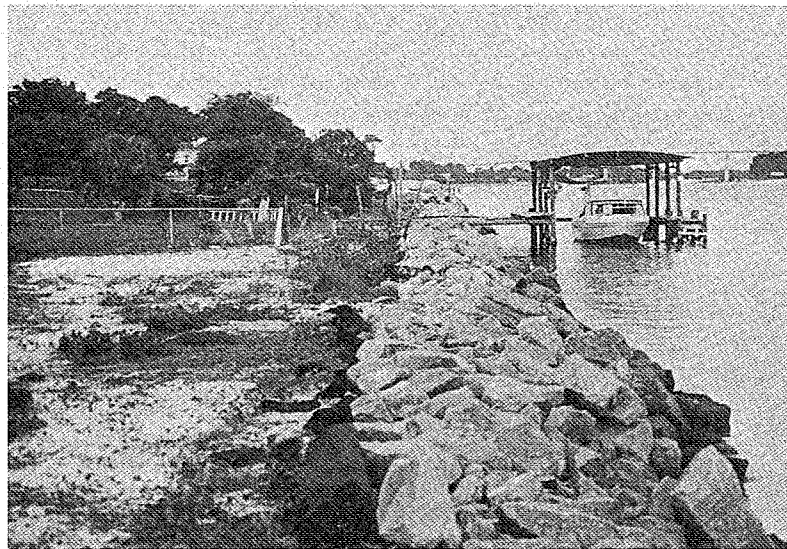
Fig. 3.6. Revetment to prevent erosion on the bay side of Perdido Key. Very few beaches remain on the bay side of Florida's developed islands. Photo by Dinesh Sharma.

Some back-side shorelines are eroding, while some are not (fig. 3.6). If a healthy salt marsh or mangrove community is growing on the lagoon side, there may be no erosion problem. If a sand bluff or stumps appear on the back side, then beware, erosion is occurring (fig. 3.7). Rates of erosion for most back-island beaches have not been determined.

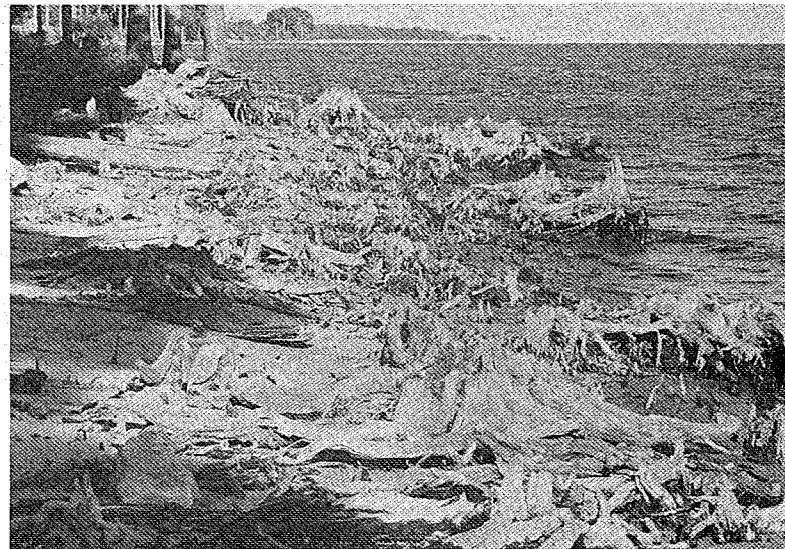
Fig. 3.7. Stumps on an eroding mainland shoreline on Apalachicola Bay. A rising sea level is the likely erosion villain here.

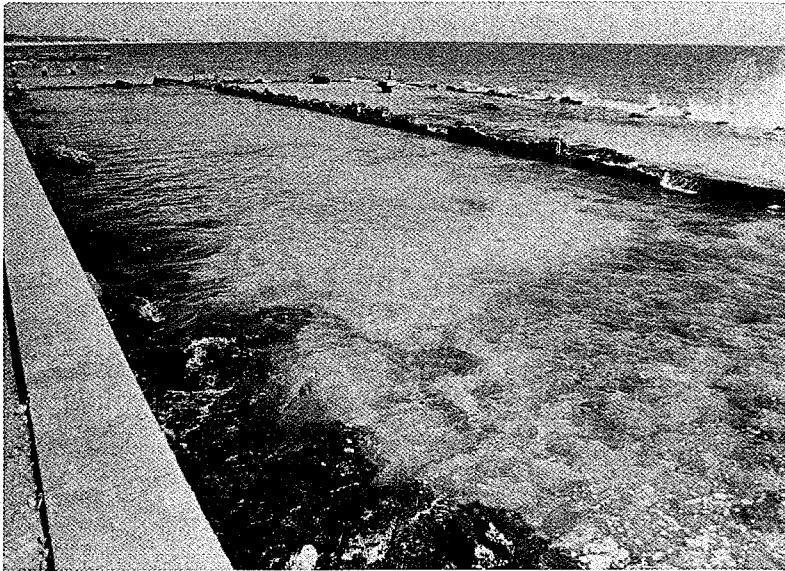
Fig. 4.1. A triple seawall on an eroding shoreline on Longboat Key. The walls were built as the shoreline retreated. Photo by Judson Harvey.

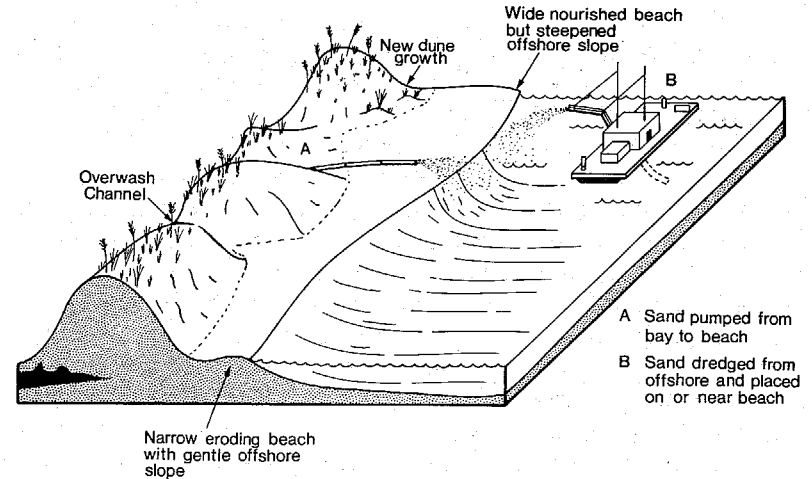
Fig. 4.2. Beach replenishment is the gentlest means of shoreline stabilization, but stabilized beaches tend to erode at a rapid rate.

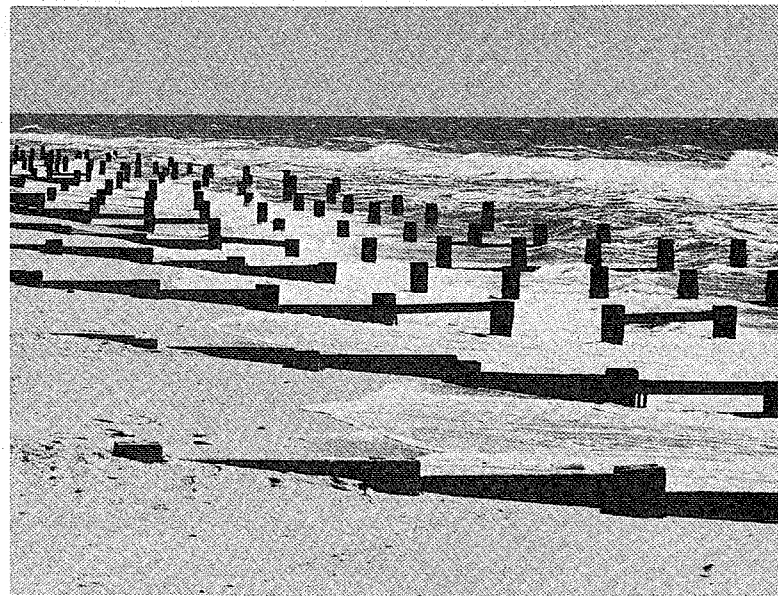
Fig. 4.3. Erosion control with groins on Longboat Key. The groins are probably having little effect except to clutter the beach. Photo by Al Hine.

Groins, much smaller walls built on straight stretches of beach away from channels and inlets (figs. 4.3 and 4.4), are intended to

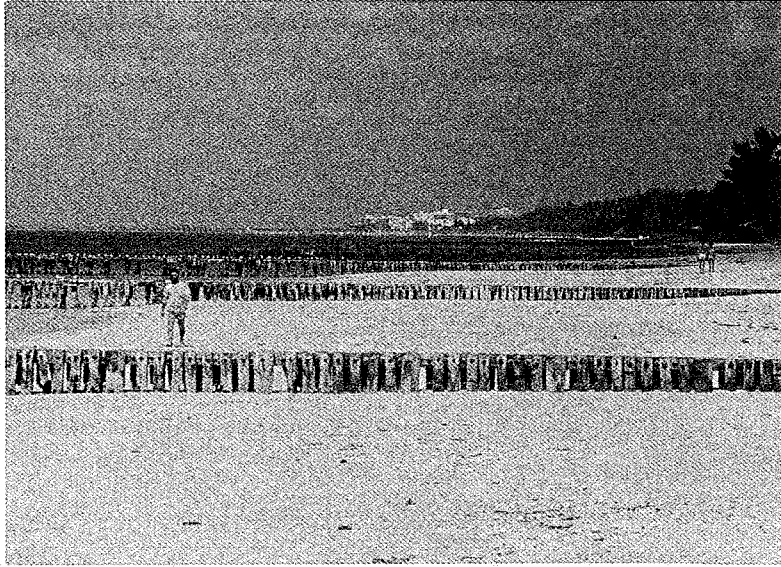
Fig. 4.4. Erosion control with groins on Naples Beach. Photo by Dinesh Sharma.

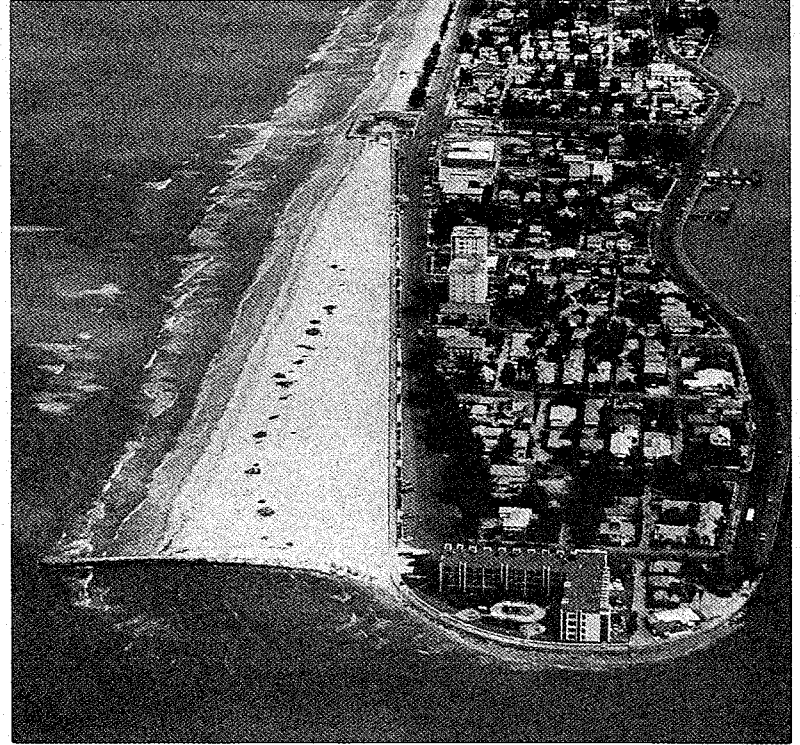
Fig. 4.5. A small jetty at the end of the beach at St. Petersburg. The jetty has trapped sand and widened the beach. Note the condo adjacent to the inlet, a dangerous location. Photo by Al Hine.

Jetties are found at a number of Florida inlets (figs. 4.5 and 4.6).

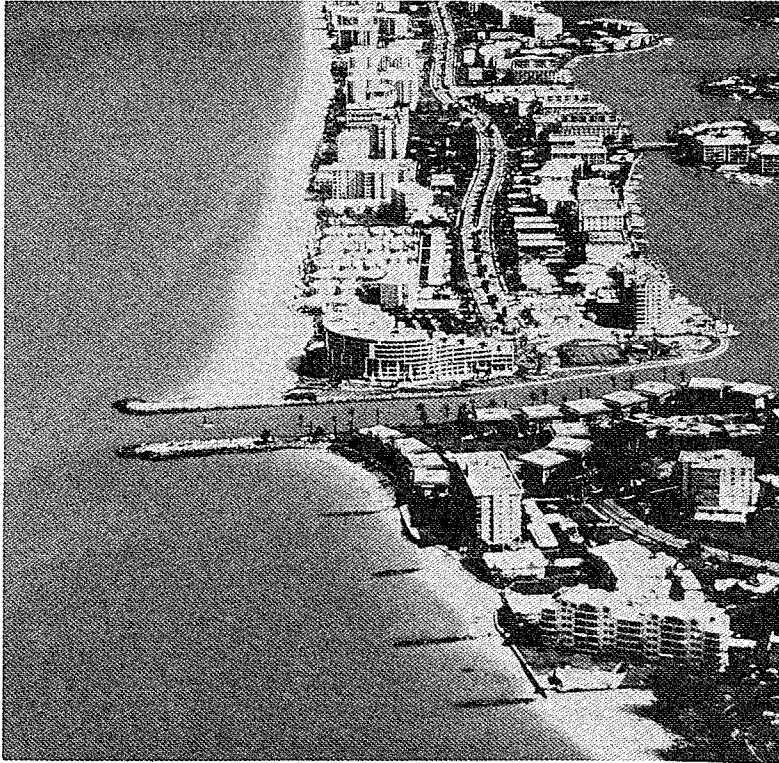
Fig. 4.6. Jetties at Naples, Florida. Sand trapped on the north side causes sand starvation and erosion to the south.

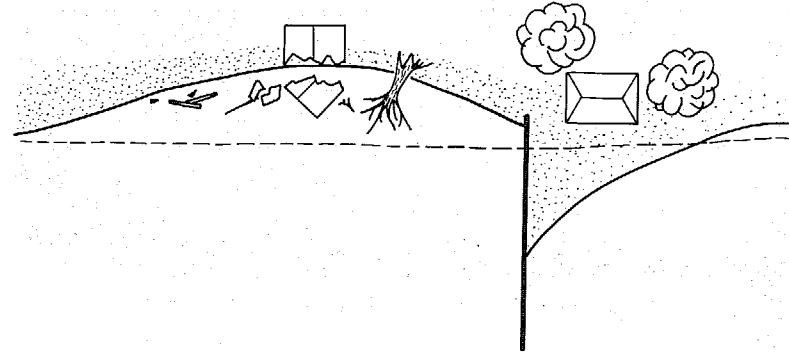
Fig. 4.7. Groins trap sand on one side and cause erosion on the other.

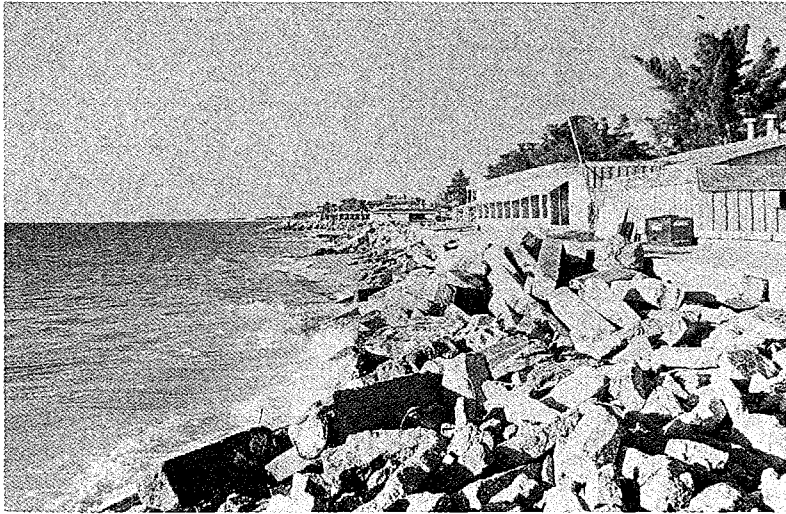
Fig. 4.8. A revetment near the Bradenton Beach City Hall. At what price have we temporarily halted erosion? Photo by Dinesh Sharma.

A third member of the seawall family is the revetment (figs. 4.8 and 4.9). These are piles of rock that slope against the first dune (or where the first dune ought to be). They have the advantage of being able to absorb, within rock interstices, some of the waves that crash into them. The water absorbed into the rock cavities reduces the amount of water that rushes back to sea between breaking waves. This also reduces the amount of beach sand lost.

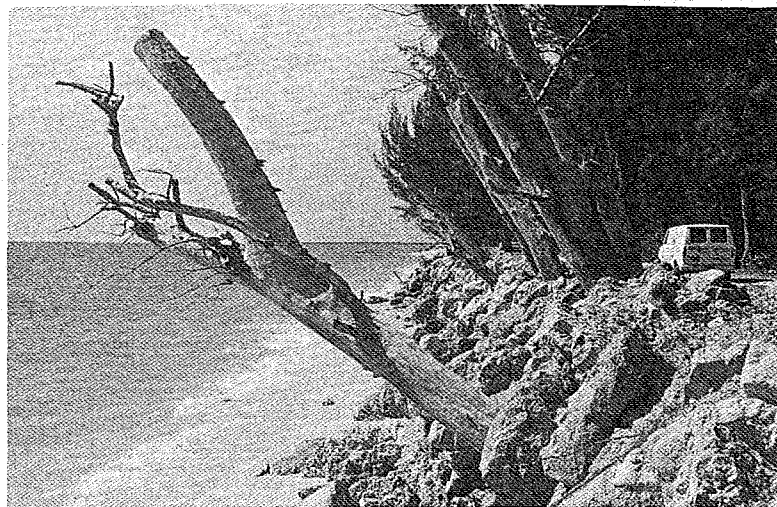
Fig. 4.9. Revetment on Captiva Island has removed most of the beach. Photo by Dinesh Sharma.

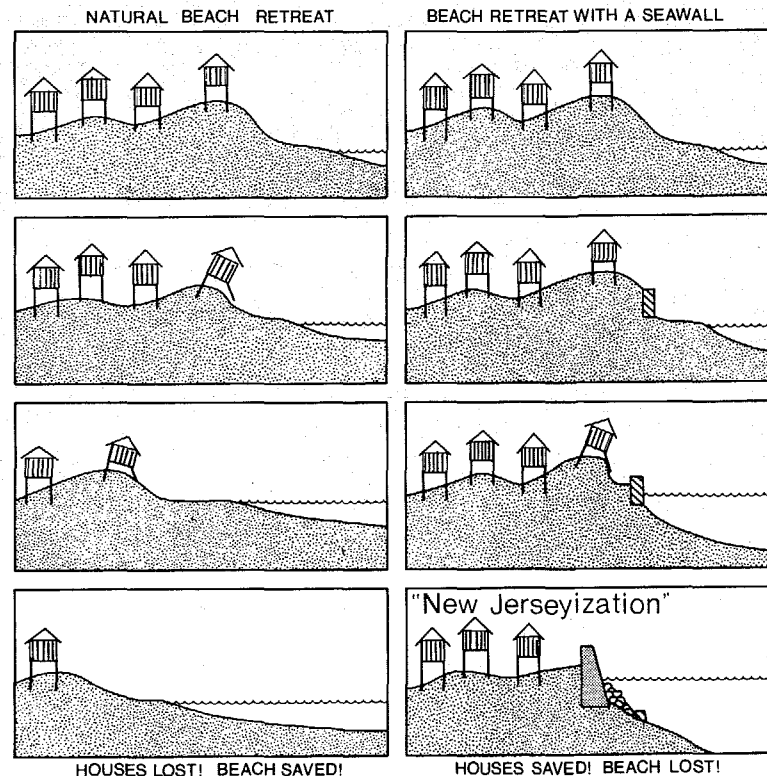
Fig. 4.10. The Seawall Saga.

1. They deflect wave energy, ultimately removing the beach and steepening the offshore profile. The time required for this damage to occur is only 1 to 30 years. The steepened offshore profile increases the storm-wave energy striking the shoreline; this in turn worsens erosion and increases the need to build a bigger and better seawall (fig. 4.10).

2. They increase the intensity of longshore currents at the base of the wall, hastening removal of the beach (fig. 4.10).
3. They prevent the exchange of sand between dunes and beach. Thus, the beach cannot supply new sand to the dunes on the island, nor can the beach flatten as it tends to do during storms.
4. They concentrate wave and current energy at the ends of the walls, increasing erosion at these points ("the end-around effect").

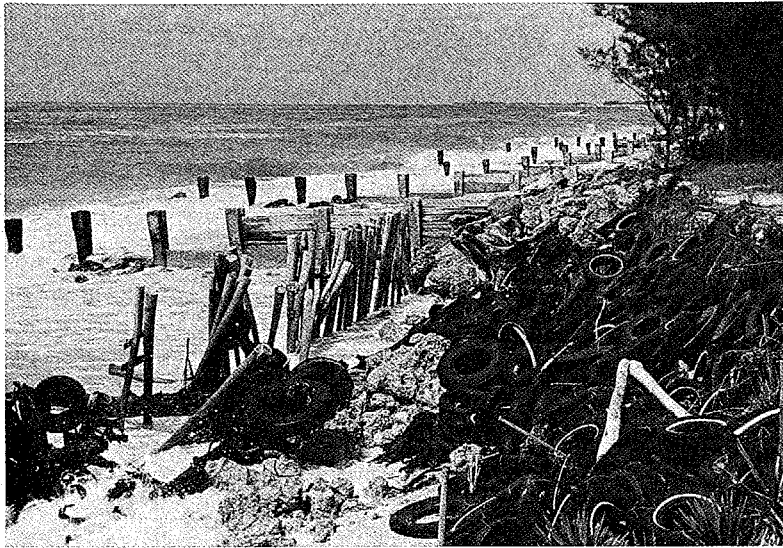
Fig. 4.11. A stretch of shoreline on Casey Key where local shoreline dwellers have been persistent if not successful in combating their erosion problem. In all, 4 different methods have been tried here. Can you spot all 4? Photo by Dinesh Sharma.

Emplacement of the many walls and revetments on Clearwater Beach, Treasure Island, Long Key, and elsewhere must be considered an irreversible act (fig. 4.11). As any casual observer of the Pinellas County beaches knows, the beaches are gone or going in front of the walls, and many of the original walls have been re-
